Monitoring the transformation of historic features in Antarctica and Svalbard: local processes and regional contexts

Ricardo Roura

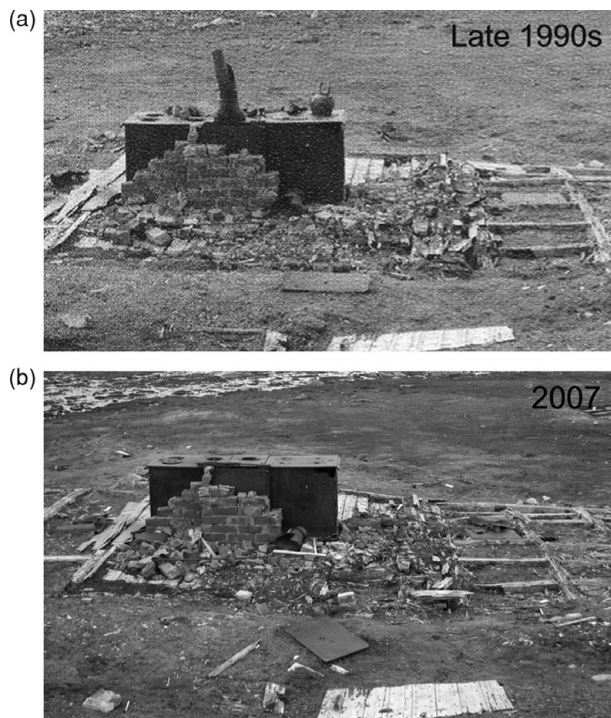
fieldwork in July 2007 (Roura 2008a). For the purposes of this article the analysis will focus on a single feature, a house foundation in which a cooking stove remains standing (78° 57' 49" N, 12° 03' 06" E) (Fig. 1). This feature stands out in the landscape and is close to the beach at which most visitors land and to the buildings used as field accommodation. It is therefore one of several cultural features of Ny-London where visitors tend to congregate. The definition of the 'before' photograph was poor; consequently, the analysis focused only on the most obvious changes (Fig. 2). Among some minor changes to small objects, some objects placed on top of the stove visible in the late 1990s, which at some point had been used for shooting practice, had been removed from that position some ten years later. However, an on-site examination of the stove showed that in 2007 these objects were still on the site albeit not visible from where the photo-couple had been taken. Some objects were lying on the building floor and others had been stored inside the cooking stove. This suggested that the rearrangement of objects had resulted from a combination of wind action and human agency.

Fig. 1a-b. House foundations with a cooking stove, Ny-London, Svalbard, in the late 1990s and in 2007. 1990s photograph by Governor of Svalbard. 2007 photograph by author.

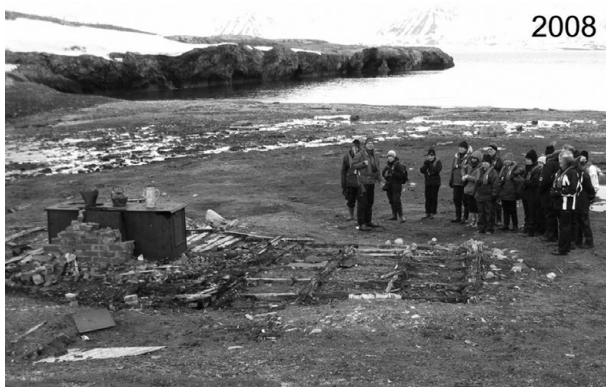
A photograph of the same site taken in 2008, that is, a year after the 'after' photograph described above showed further changes to the site (Fig. 3). Some objects had been replaced on top of the stove, and other objects had been removed from sight or had changed position within the frame. Overall, the condition and integrity of the site did not change significantly between 1997 and 2007, or between 2007 and 2008. However, it is apparent that the site is not static; that it is regularly visited; and that cultural remains that had once been used as shooting targets are now put on display for visitors.

Fig. 3. Tourists visit Ny-London, July 2008. Note items on the top of the stove that were absent in 2007. Photograph by M. Loonen.

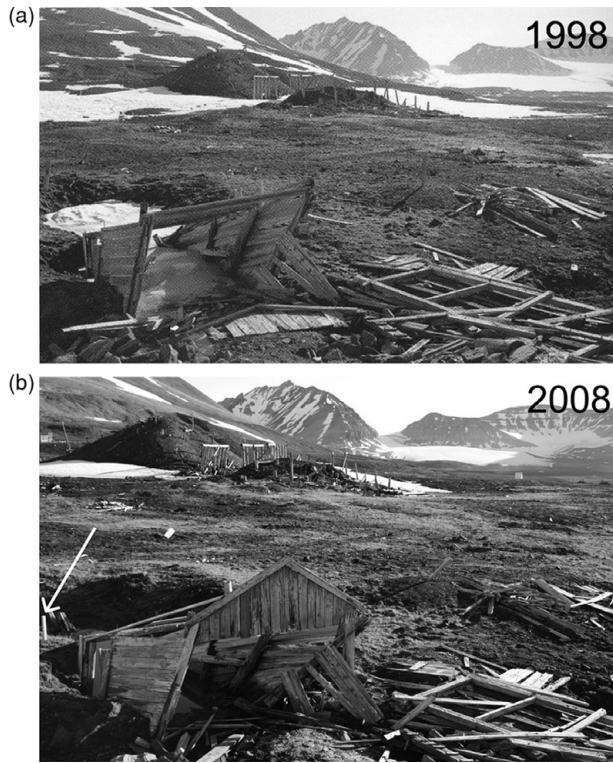
Fig. 4a-b. Entrance to 'Josefine' coal mine near Ny-Ålesund, in 1998 and 2008. The arrow in the right photograph shows a wooden peg planted by mining veterans in 2006 to identify the site. 1998 photograph by Governor of Svalbard. 2008 photograph by M. Loonen.

relatively short part of their working lives in the coalmines at Ny-Ålesund (O. Bye, personal communication, 29 June 2007). As part of several initiatives to maintain the memory of mining times, in 2006 a group of veterans and their supporters marked with pegs and documented several sites of interest around the mining area so that their location would not be lost (Paulsen 2006). One of those pegs, marking the entrance to 'Josefine', is visible in Fig. 4b.

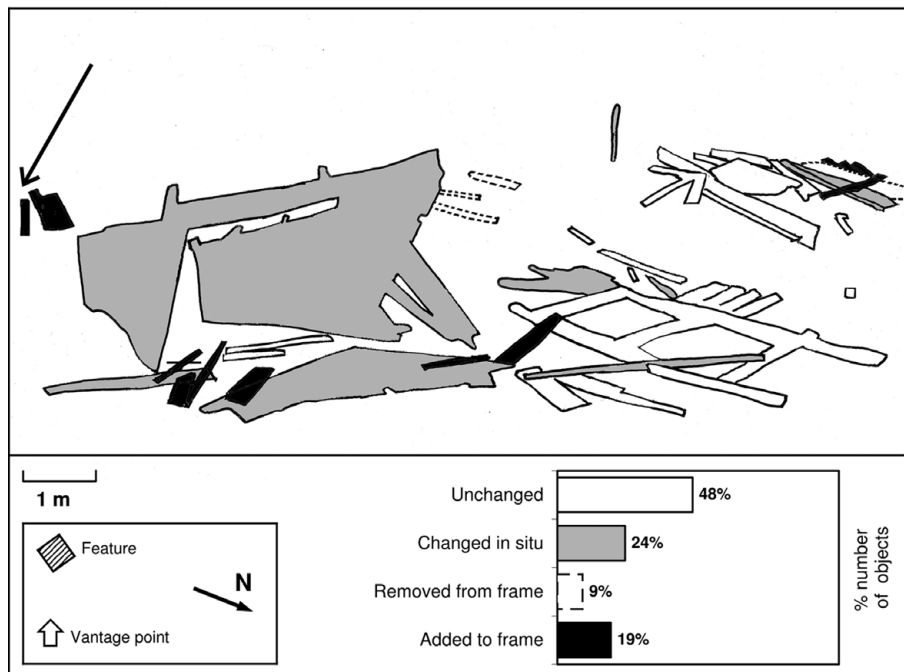
Fig. 5. Overview of changes to the entrance to the 'Josefine' coalmine near Ny-Ålesund between 1998 and 2008. The arrow in the 2008 photograph shows a wooden peg planted by mining veterans in 2006 to identify the site. Sketch based on 1998 photograph. Key: white = no changes; grey = changes within the frame; dashed line = removed from frame; black = added to frame.

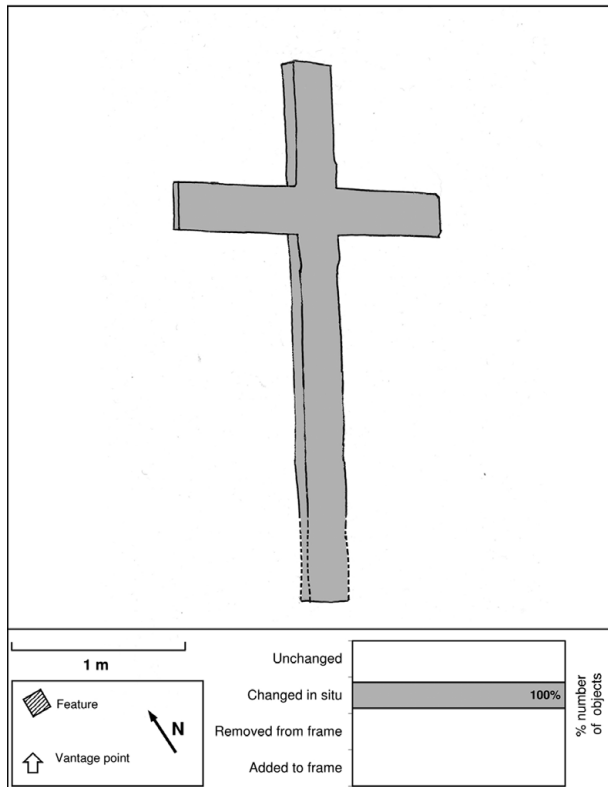
The changes to the cross' orientation and integrity since 1990 (Fig. 7) may be explained by the fact that it was downed by hurricane force winds in June 1993. The cross was restored by members of the New Zealand Antarctic programme and transported back by foot to the top of the 230 m hill by a team from the nearby stations from the United States and New Zealand (NZAHT 2008). There are some minor dents and scratches on the cross, some of which may be related to its downhill fall (or falls). At the back of the cross there are some faint traces of engraved graffiti. The cross stands on a concrete base, upon which some people have written down their names. These inscriptions are recent and presumably made by some of those who transported the cross back to the top of Observation Hill since they were made before the cement set. The fact that the cross is shorter now than in 1990 suggest that was broken off at the ground level when it fell.

Fig. 7. Overview of changes to the cross at Observation Hill, Ross Island, Antarctica, between 1990 and 2007. Sketch based on 1990 photograph. Key: white = no changes; grey = changes within the frame; dashed line = removed from frame; black = added to frame. Sketch by author.

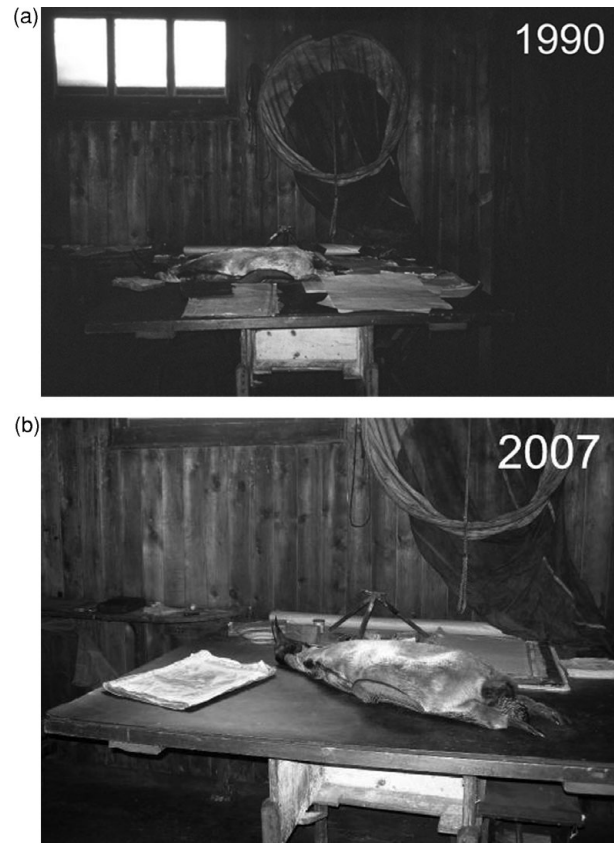
Fig. 8a-b. The chart table of R.F. Scott in the *Terra Nova* hut at Cape Evans, Ross Island, in 1990 and late 2007. Photographs by author.

During a brief visit in December 2007 photographs taken in the course of several visits to the hut through the 1990s were broadly replicated (Fig. 8). One of those sets of photographs is that of Scott's chart table. Entering the

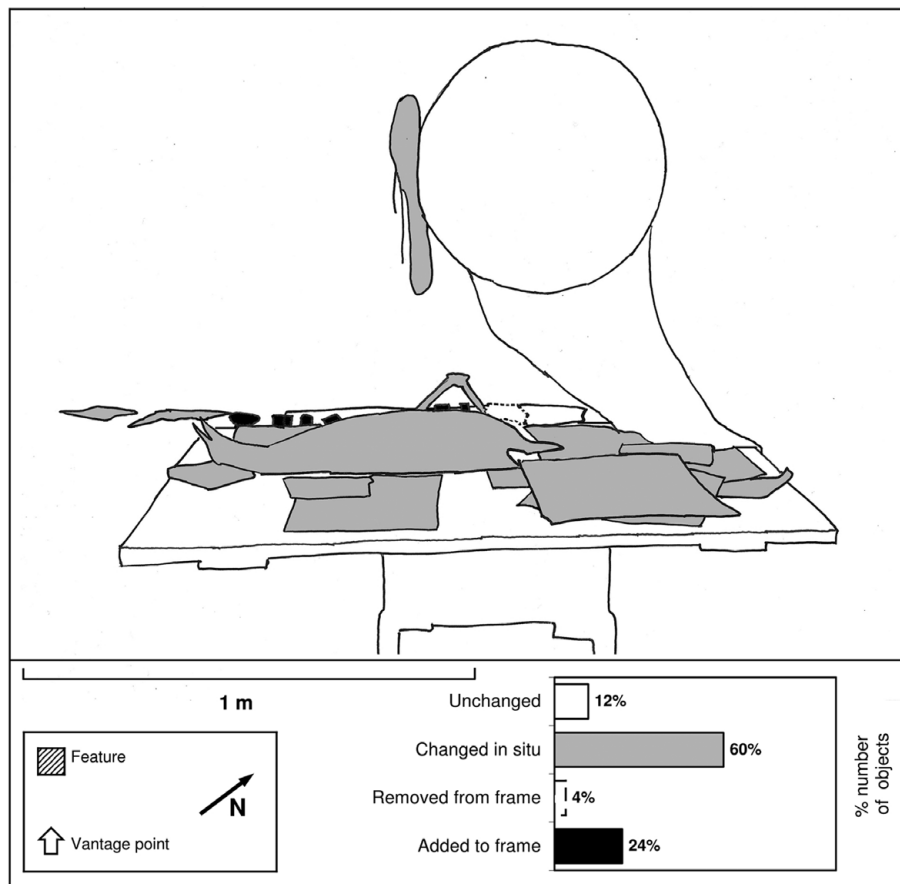
Fig. 9. Overview of changes at the chart table of R.F. Scott in the *Terra Nova* hut at Cape Evans, Ross Island, Antarctica, between 1990 and late 2007. Sketch based on 1990 photograph. Sketch by author. Key: white = no changes; grey = changes within the frame; dashed line = removed from frame; black = added to frame.

Comparing the 1990 and 2007 photographs it is apparent that the somewhat disorderly arrangement of objects on the chart table has been replaced by a tidy 'tablescape' (Fig. 9). Cultural processes are clearly the main processes of change in this case, although they may have in turn been triggered by the effect of the environmental conditions within the hut on the objects lying on the table (soft rot, fungi, corrosion and other problems affect the objects inside the hut, see for instance Blanchette and others 2002, 2004). Currently the hut is

subject to an ambitious conservation programme that aims to stabilise, maintain and repair the hut and its artefacts. This may involve '...to undo inappropriate interventions during the modern era and reflect more authentically the heroic era use of the hut' (NZAH 2004: 101). Other features of the hut and many of its artefacts are now being restored and rearranged in comparable ways.

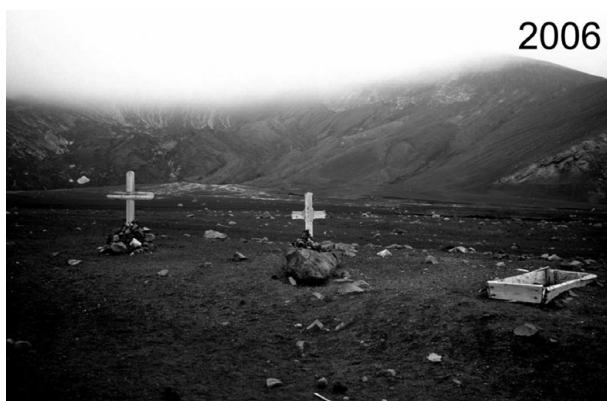
Fig. 12. The complex of mortuary features at Whalers Bay, Deception Island, Antarctica, early in 2006. Visitor footprints are apparent on the ground around the features. Photograph by L. Hacquebord.

Several comparable sets of photographs taken by the author and other visitors between 2002 and 2006 were collected for this case study (Figs. 10, 11). Since 2001–2002 Gulliksen's cross has been removed from its original location some 400m away and placed next to Knapstad's cross and the coffin remains (Fig. 12). Small rock cairns

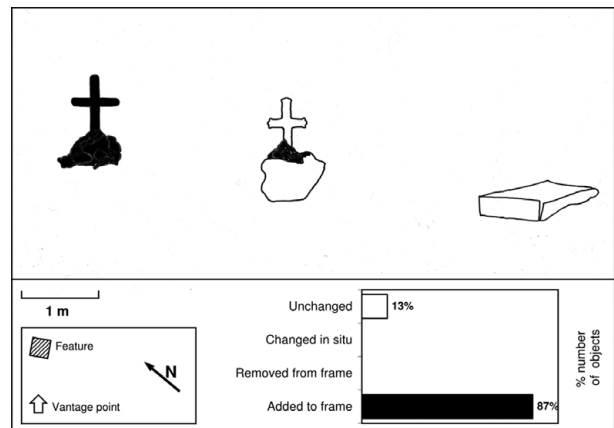
Fig. 13. Overview of changes to the complex of mortuary features at Whalers Bay, Deception Island, Antarctica, between 2002 and 2006. Sketch based on 2006 photograph. Assumes that the rocks in the cairns were added to the frame. Sketch by author. Key: white = no changes; grey = changes within the frame; dashed line = removed from frame; black = added to frame.

The changes observed between 2001–2002 and 2004–2005 (Fig. 13) result from active management and tourism. Barr and Downie (2002) recommended that all mortuary elements should be placed together and apparently this has been acted upon (Figs. 10b, 12). The original cemetery has not been reconstructed but has been somehow recreated approximately where it used to be. The cairns most likely developed as a cumulative feature built by accretion. Visitors at polar historical sites follow a basic behavioural repertoire that includes making a record of the visit either by taking something from the site (for instance, photographs) or by leaving something on the site (for instance, a signature in a visitors book) (Roura in press). It is interpreted that many of the rocks in these cairns would have been placed spontaneously by successive visitors to Whalers Bay as a record of their visit and as a mark of respect and permanence (what Schiffer (1987: 80) calls 'offertory shrine').

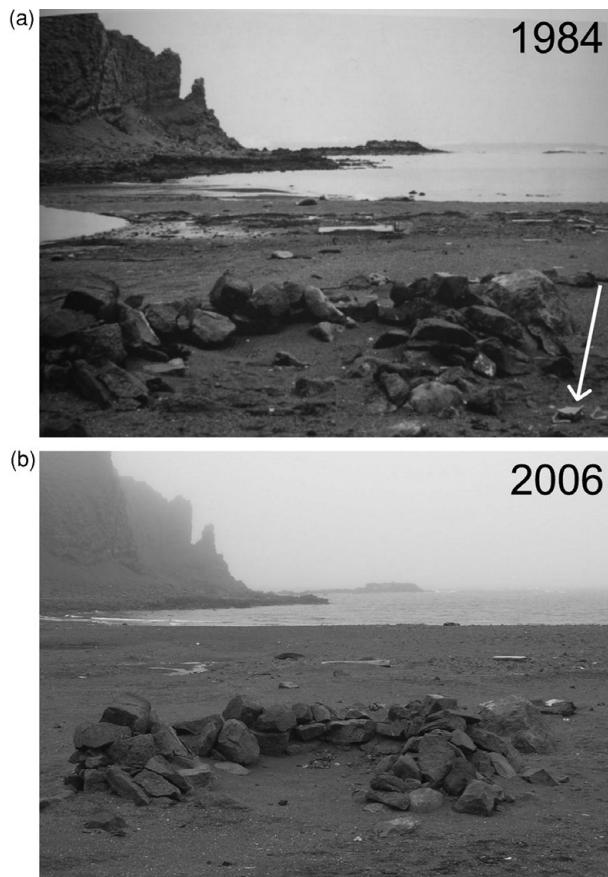
Fig. 14. a-b. Sealer's shelter at Cuatro Pircas, Fildes Peninsula, King George Island, Antarctica in 1984 and 2006. The arrow on the earlier photograph shows fragments of pottery. 1984 photograph by R. Stehberg. 2006 photograph by author.

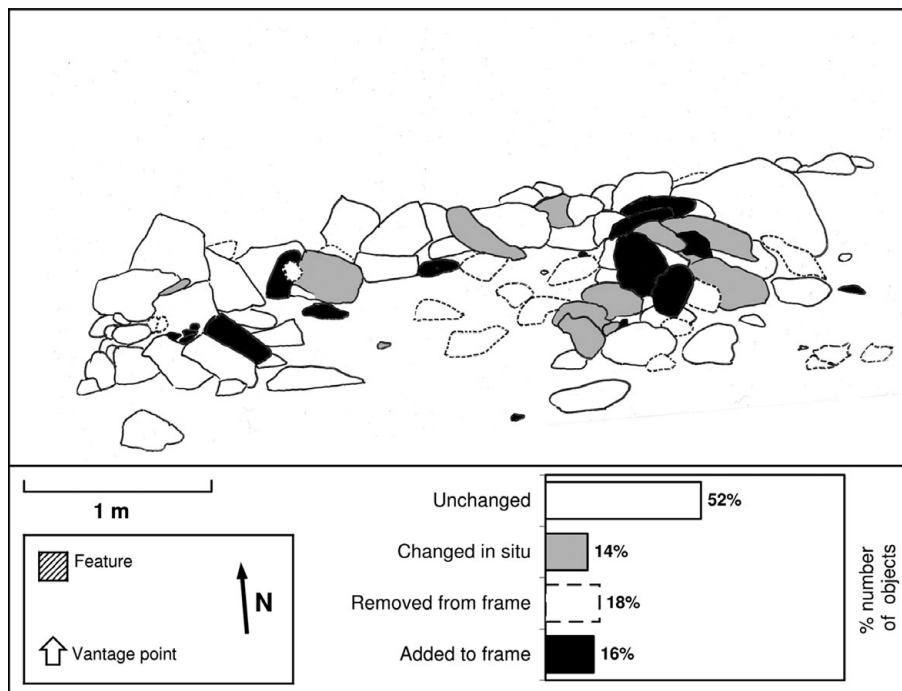
Fig. 15. Overview of changes at the sealers shelter at Cuatro Pircas, Fildes Peninsula, King George Island, Antarctica between 1984 and 2006. Sketch based on 1984 photograph. Sketch by author. Key: white = no changes; grey = changes within the frame; dashed line = removed from frame; black = added to frame.
